The January 17, 1994, Northridge Earthquake, California

H. S. Lew¹, Jim Cooper², Sam Hacopian³, Walter Hays⁴, and Mike Mahoney⁵

ABSTRACT

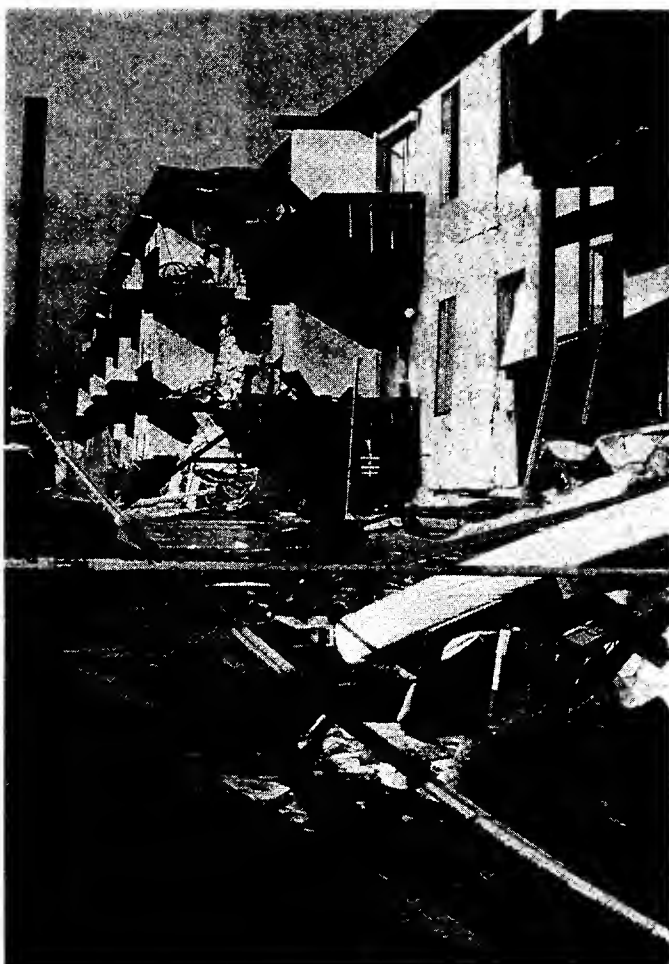
collapsed. The first story gave way while the second and third stories remained largely intact. The sixteen people killed were in the first story apartments. All the buildings in the complex suffered some damage (Figure 5).

Figure 5 At the Northridge Meadows apartment complex near the epicenter the first story in several of the buildings collapsed, killing sixteen people. The second and third stories remained essentially intact. Large portions of the first story in these buildings were open space for parking. This type of collapse occurred in a significant number of similar apartment buildings throughout the affected area.

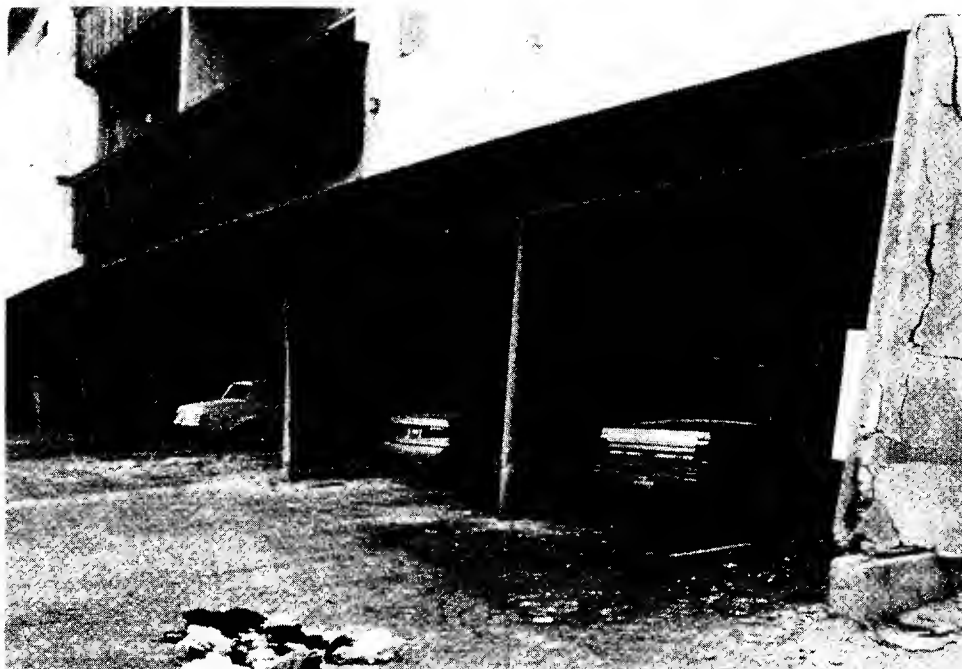
Figure 6 Steel pipe columns between parking bays supported the upper stories of the Northridge Meadows apartment buildings. Few of the buildings in the north half of the complex collapsed, but all were damaged.

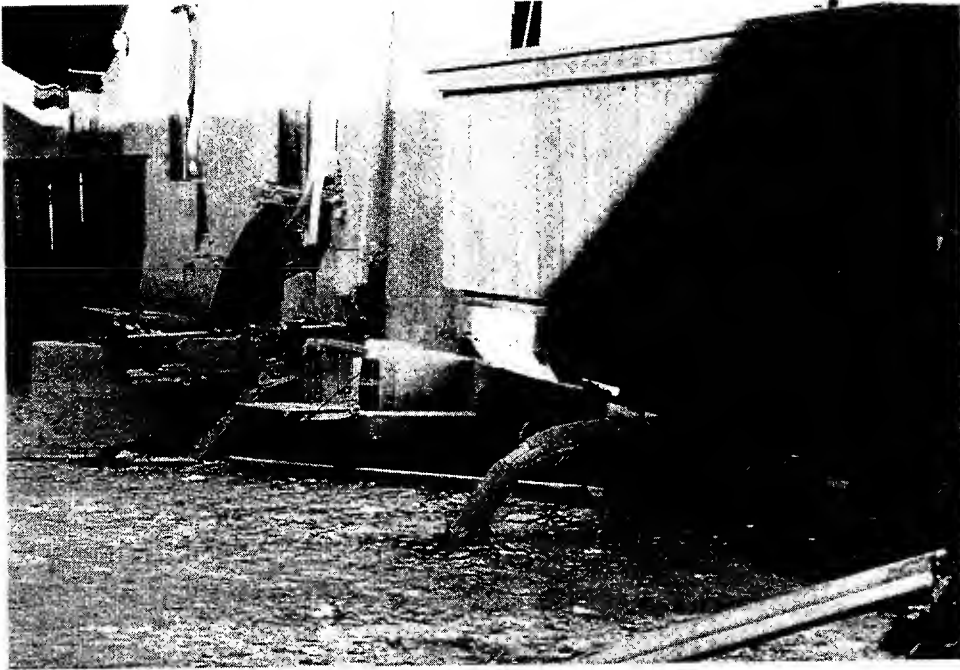
The upper stories of the collapsed buildings were displaced laterally and in some cases came to rest offset by as much as three meters from their original locations. The steel pipe columns, which hinged at their bases, apparently controlled the distance of the offset as they bent to the ground (Figure 7). The Northridge Meadows building configuration, two stories of living space in a long, narrow building above one level of parking, is common in the San Fernando Valley. Many buildings of this type sustained serious damage, and some collapsed. These buildings were also built in the late 1960's or early 1970's, when use of stucco for seismic resistance in low-rise buildings was common. Current codes have essentially banned the use of this material.

Figure 7 At Northridge Meadows, the first story steel pipe columns generally hinged near their bases but retained their length, controlling the displacement of the upper stories.

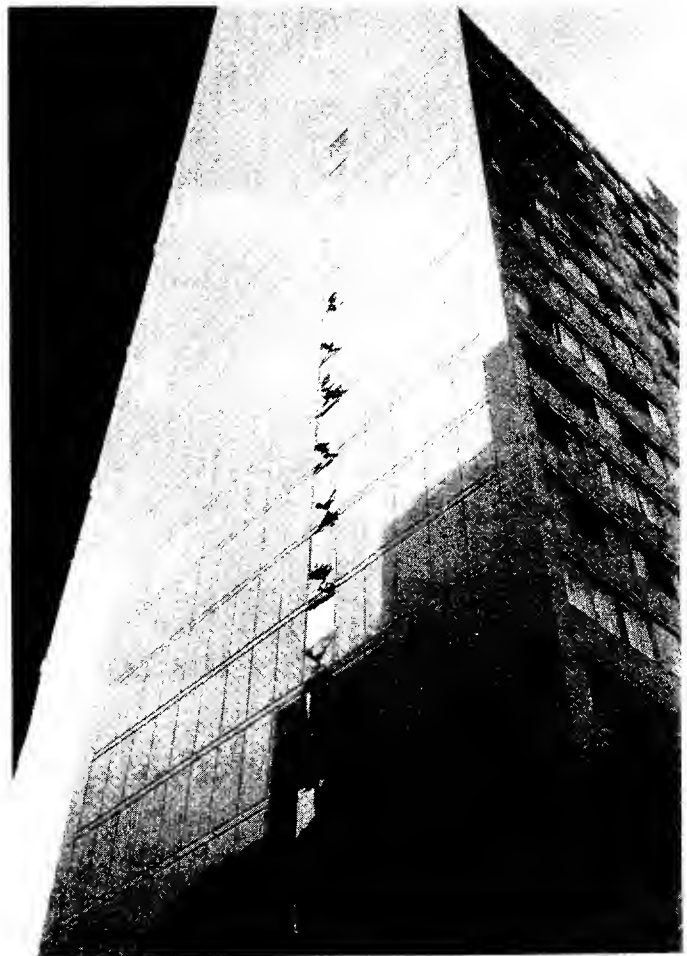
The transverse end walls are pierced by a single vertical row of window openings. The wall segments between the windows act as coupling beams linking the wall segments on either side. These beams suffered serious diagonal cracking (Figure 8). In the longitudinal direction, the lateral-force resistance is provided by concrete moment frames. The front of the building shows

Figure 8 Champagne Towers apartment building in Santa Monica suffered a classic form of earthquake damage: shear failure of the coupling beams between linked shear walls at the transverse end of the building.

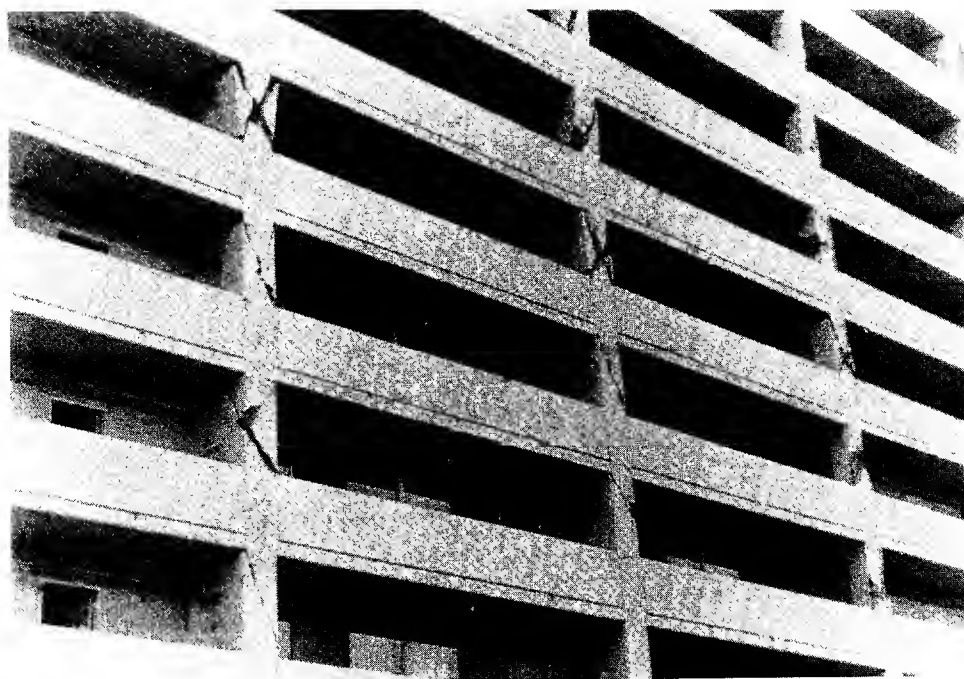
no sign of damage. At the back, the columns and transverse wall ends are diagonally cracked (Figure 9). The solid infill railings which rise to about mid-height of the columns create an unintentional "short-column" effect, causing the columns to fail in shear. At the front of the building, metal pipe railings are provided at the balconies rather than solid infill, as at the back. This may partially explain why there is no apparent damage at the front of the building.

Figure 9 The back of the Champagne Towers building was badly damaged. The railings here are solid infill, which effectively stiffen the lower half of the columns. The shortened upper half of the columns were forced to accommodate all the displacement, and they failed in shear.

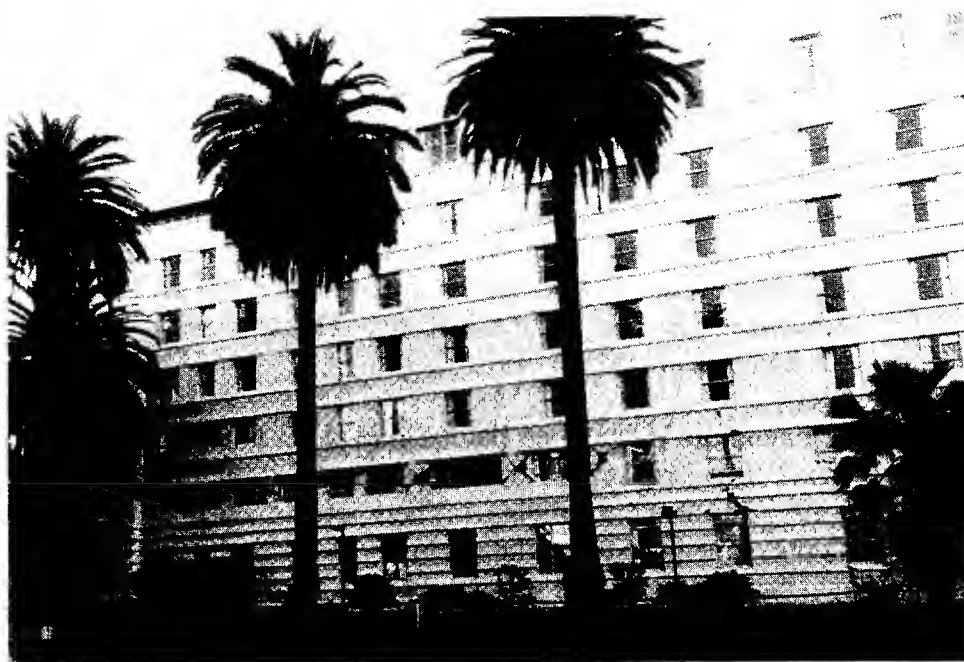
The original hospitals of Holy Cross and Olive View were badly damaged in the 1971 San Fernando earthquake. They were rebuilt following the requirements of the Hospital Act introduced by the State of California after the 1971 quake. The structural systems of these two hospitals performed well in the Northridge earthquake. However, damage to the sprinkler and chilled water systems at Olive View rendered the building temporarily unusable. At Holy Cross, damage to the air handling system forced closure of the hospital. However, St. John's Hospital in Santa Monica was closed due to structural damage. The 7-story northwest wing, which was built in 1952, had severe diagonal cracks in the piers between windows (Figure 10).

Figure 10 The seven-story northwest wing of St. John's hospital in Santa Monica experienced severe X-cracking in the piers between the second story windows.

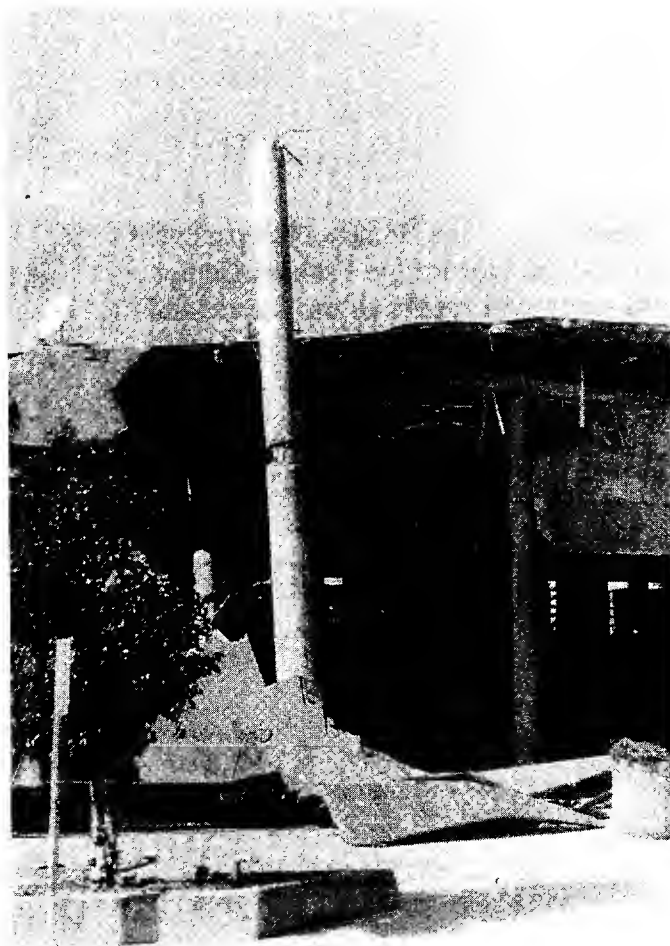
The collapse of large portions of the roof and floors of the 3-story concrete Bullock's department store at the Northridge Fashion Center could have caused more deaths than any other single building failure in this earthquake. Many multi-story columns were left intact as the concrete slab floors and roof fell on top of each to the basement, presumably due to punching shear failure of the slabs. The remaining-standing columns showed no evidence that slab reinforcement had been continuous through the columns (Figure 11).

Figure 11 A portion of the concrete waffle slab roof and the interior floor slabs at the Bullock's department store at the Northridge Fashion Center mall fell to the basement, leaving many of the columns standing. No reinforcing steel can be seen in the remaining columns that would have connected the columns to the floor slabs.

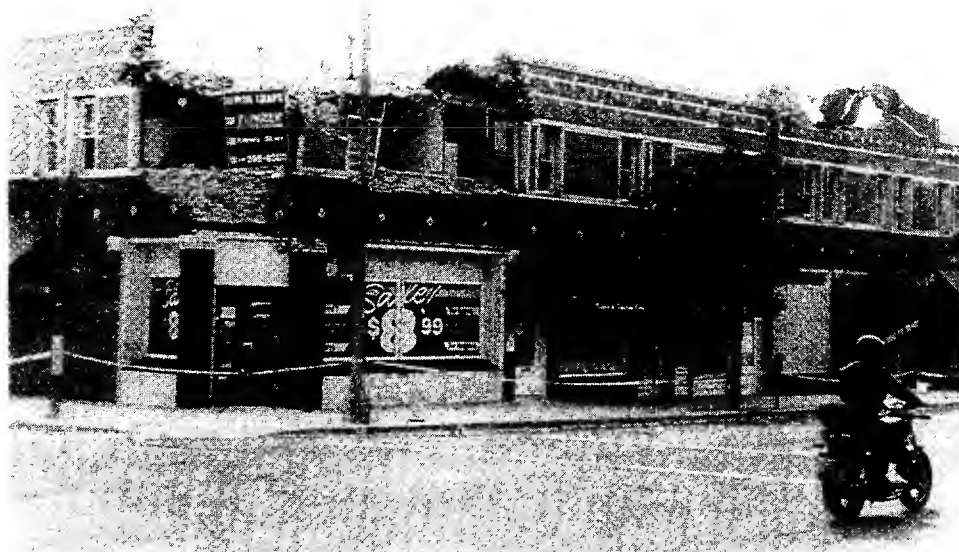
Figure 12 Damage to unreinforced masonry buildings, even those that had been rehabilitated, was common. Upper stories and corners were particularly vulnerable to damage. The rows of light-colored diamonds on the face of this building are the end plates of through-bolts used to connect the wall to the floor joists, a typical rehabilitation technique. The remains of parapet braces can be seen on the roof.

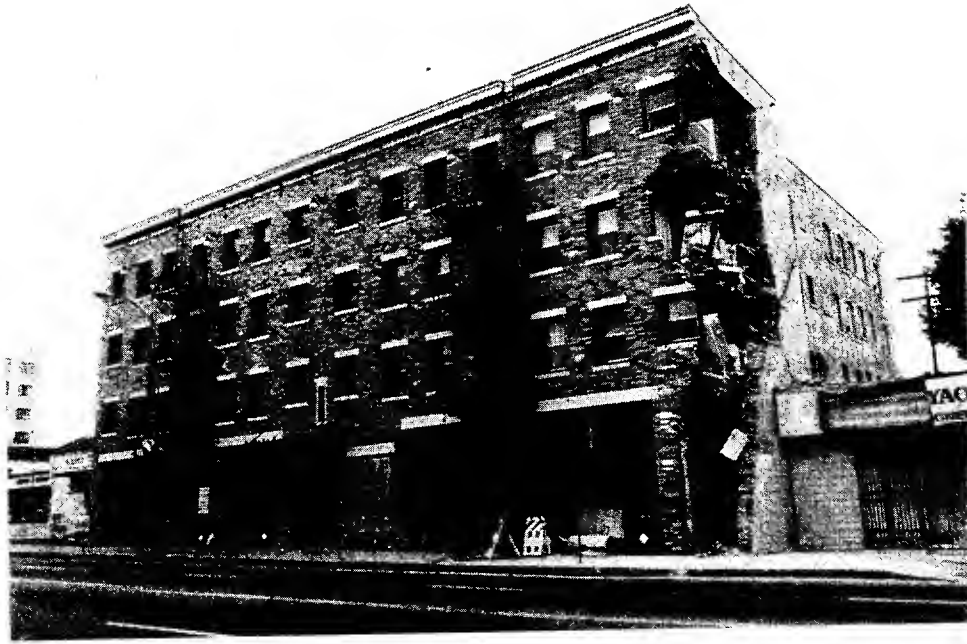
Figure 13 The corner of this rehabilitated unreinforced masonry apartment building in East Hollywood crumbled on all four stories.

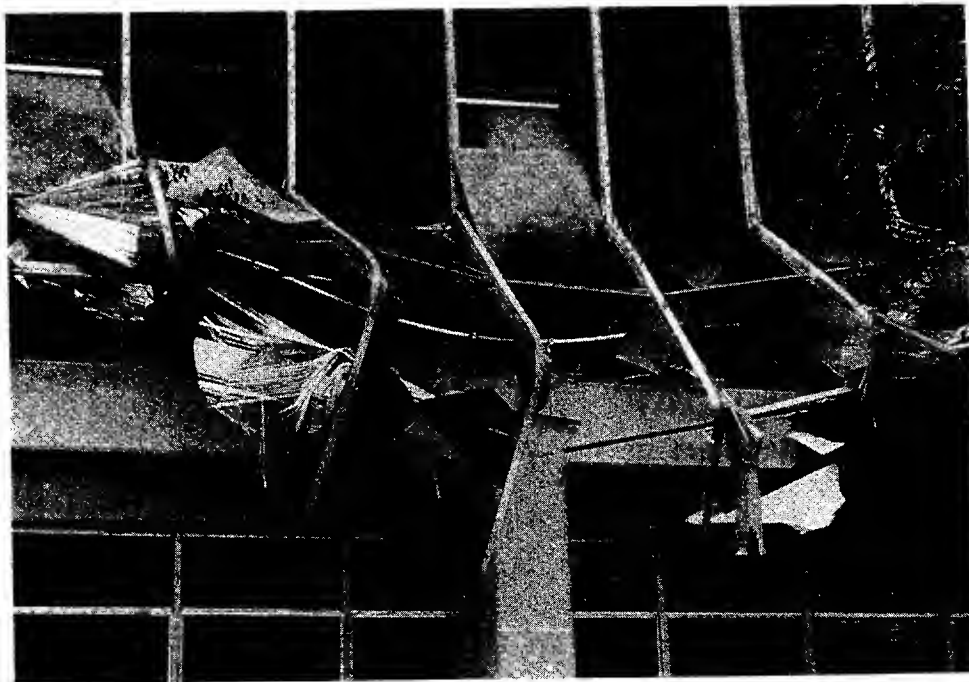
The Kaiser Permanente office building on Balboa Boulevard in Northridge was badly damaged. The second story columns disintegrated, causing the upper stories to collapse onto the first story, which remained intact (Figure 14). The bare frame exposed by the damage suggests that the buildings had a strong-beam/weak-column configuration (Figure 15). The damage appears to have initiated at the joints.

Figure 14 The second story of the concrete frame Kaiser Permanente office building on Balboa Avenue in Northridge completely collapsed. The first story was relatively undamaged, suggesting it was far stiffer than the story above.

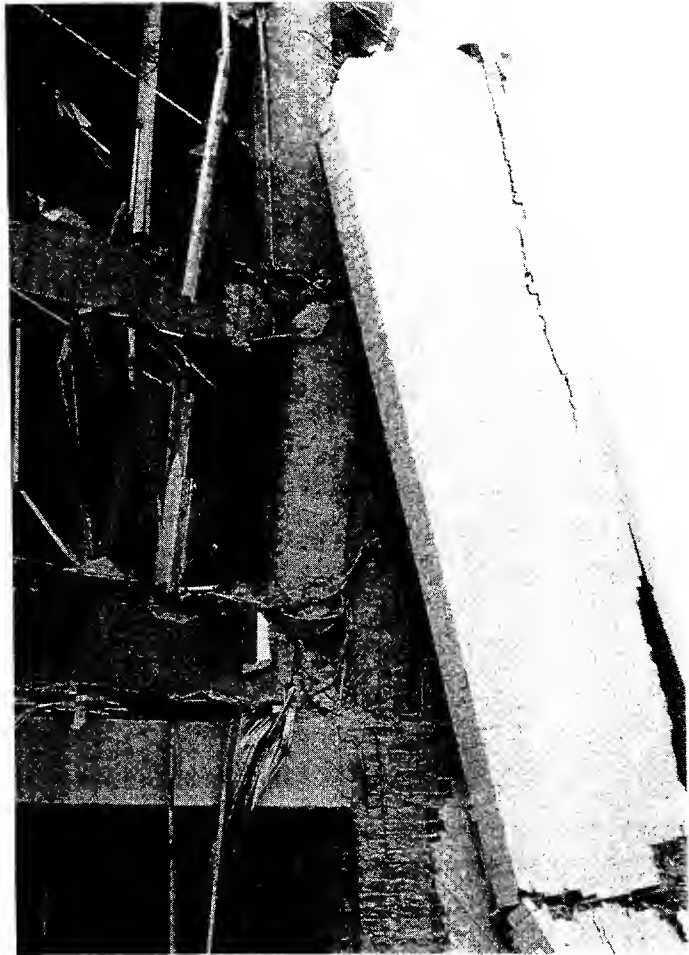
Figure 15 The exposed concrete frame of the Kaiser Permanente building, revealing deep beams, suggests that the building had a strong-beam, weak-column configuration. Except for the second story columns, the columns and beams remained intact while the joints disintegrated.

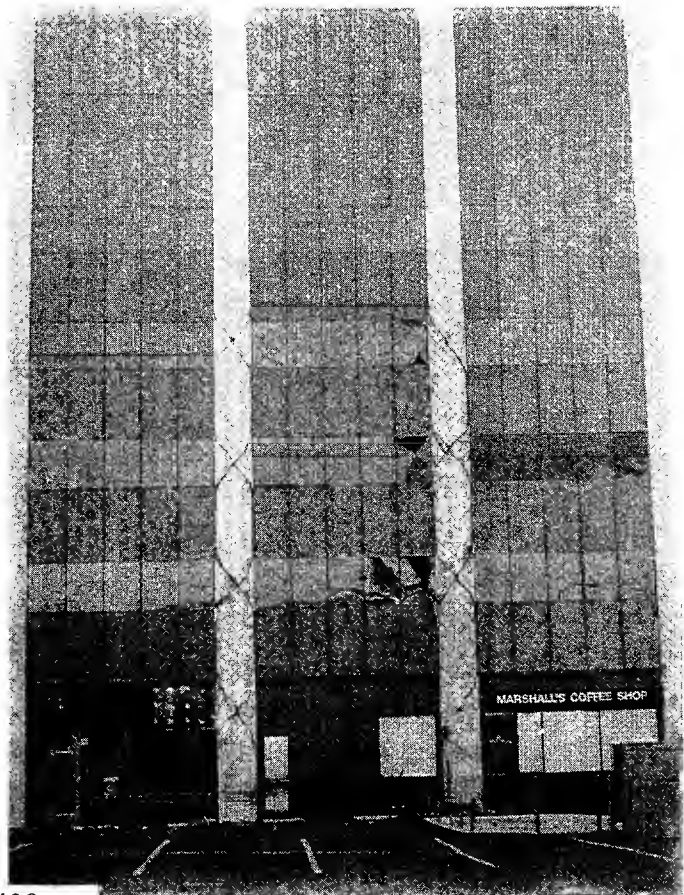
The L-shaped concrete frame Barrington Building in West Los Angeles also had damage concentrated in the second story columns (Figure 16). The horizontal architectural panels stiffened the lower half of the columns at each story, creating a short-column effect.

Figure 16 The stiff infill panels of the Barrington Building effectively shortened the concrete columns, forcing all the displacement into the column sections bounded by windows. Diagonal X-cracking decreased in severity towards the top of the building.

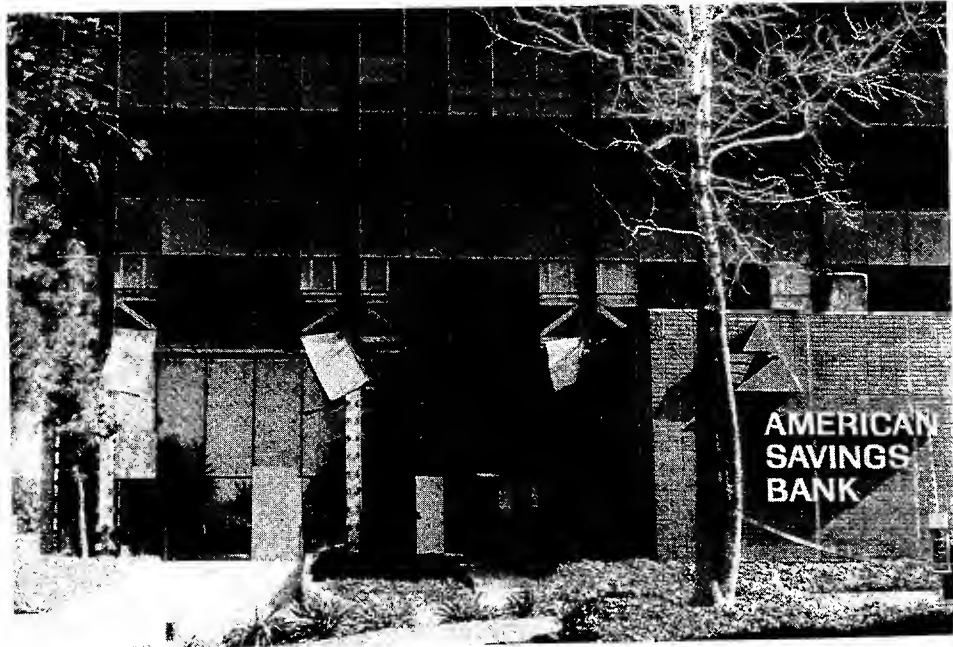
A steel-frame office building on the west side of Topanga Canyon Boulevard in Canoga Park, housing the American Savings Bank, experienced significant movement in its first story columns (Figure 17). A nearly identical building on the same site, oriented at right angles to the first, had only minor damage to glass at the first story. The first story column heights of the two buildings differed significantly: the ones in the undamaged building were considerably shorter than the ones in the damaged structure.

Figure 17 The first-story columns of the steel-framed building housing the American Savings Bank on Topanga Canyon Road in Canoga Park flexed during the quake and ended up slightly displaced from their original positions.

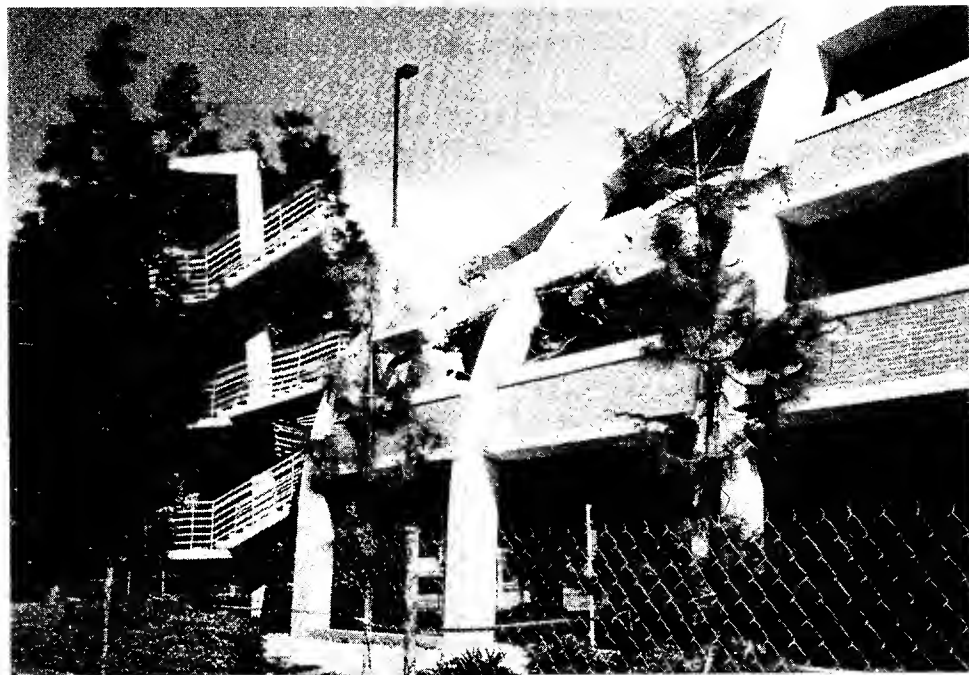
Figure 18 The three-year old four-level parking garage at the Northridge campus of California State University partially collapsed in the earthquake. The collapse apparently started at the interior, causing the exterior walls to be pulled in to the middle of the structure. Precast concrete "trees" were connected to form a moment-resisting frame at the exterior of the structure.

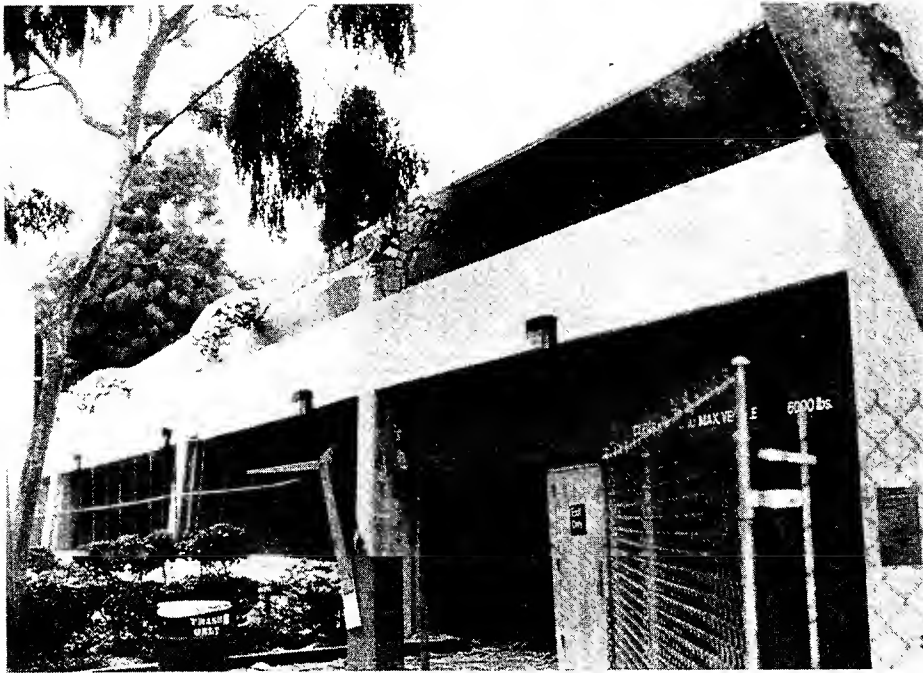
The five-level parking garage in West Los Angeles experienced a similar collapse. All four facades were pulled inward, suggesting that interior damage precipitated the failure (Figure 19). The garage was a post-tensioned, cast-in-place concrete structure with shear walls providing the lateral-force resisting system at the east and west ends, and moment frames at the north and south perimeter. The shear walls were cracked horizontally throughout their height due to the out-of-plane bending (Figure 20).

Figure 19 The cast-in-place concrete parking garage at the Kaiser Permanente Hospital complex in West Los Angeles collapsed in on itself. The moment frame that provided lateral resistance on the south face of the structure could not resist the out-of-plane forces apparently caused by the collapse of interior elements.

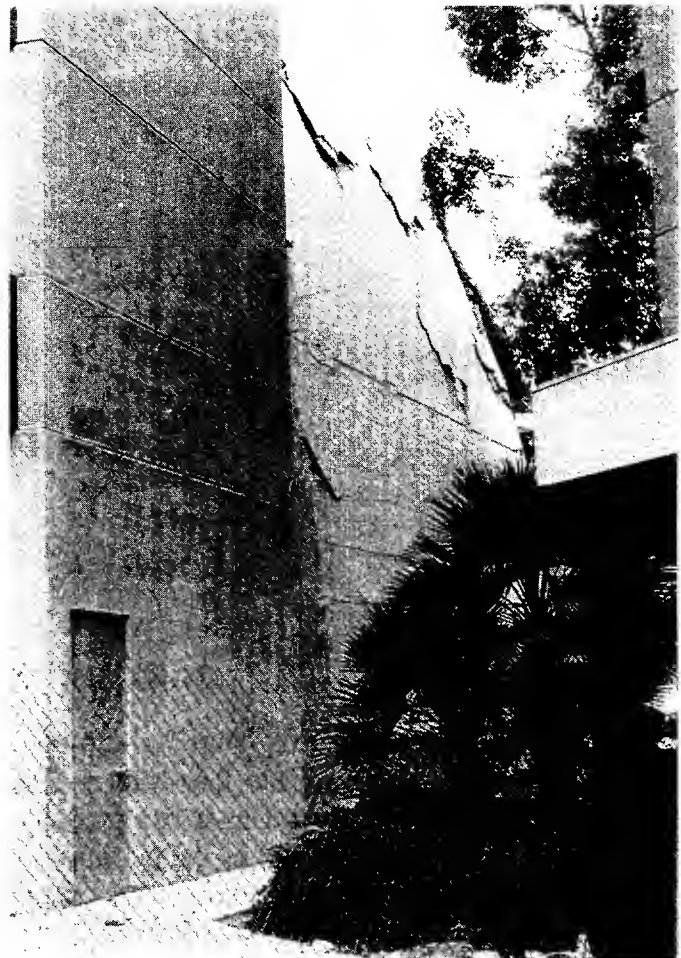
Figure 20 - At the east and west faces of the Kaiser Permanente Hospital parking garage, shear walls made up the lateral force resisting system. Both walls had horizontal cracks caused by the out-of-plane bending when the walls were pulled inward. Neither wall had major diagonal cracking, suggesting that the lateral load was never fully delivered to the walls. The stair towers remained erect. The east wall and stair tower are shown here.

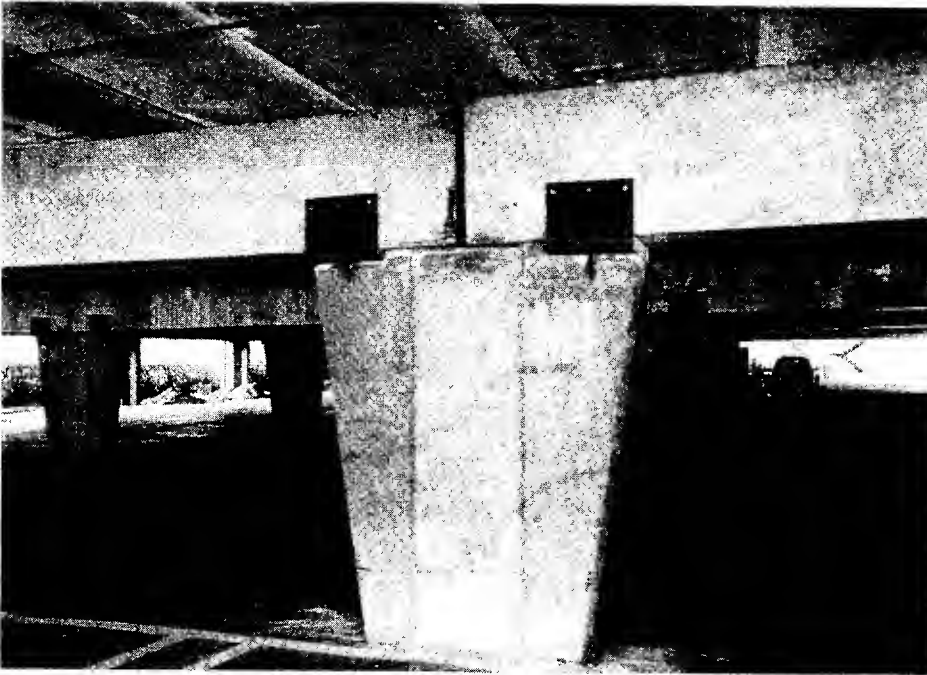
The two-level concrete parking structure adjacent to the Trans World Bank in Sherman Oaks had been seismically strengthened after suffering serious damage in the 1971 San Fernando quake. Flared extensions were cast next to the interior columns along their north-south axes (Figure 21), creating short wing walls supporting the precast beams.

Figure 21 The interior columns of the two-level parking garage at the Trans World Bank in Sherman Oaks had been seismically strengthened after it suffered damage in the 1971 San Fernando quake. The interior columns fared well in the 1994 Northridge quake.

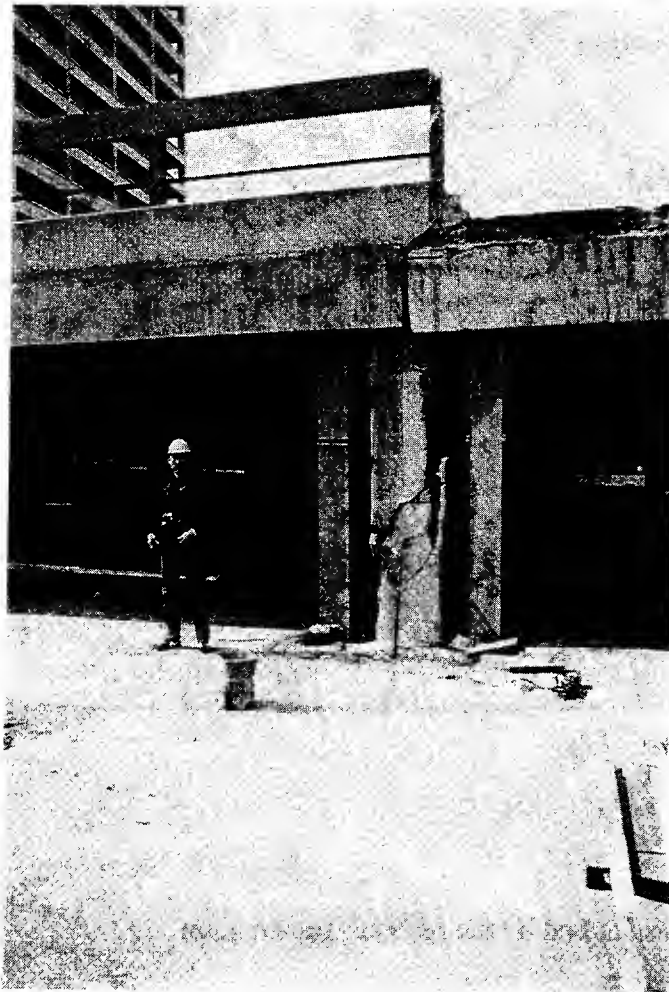
The unrehabilitated exterior columns were badly damaged in the Northridge earthquake (Figure 22).

Figure 22 The exterior columns of the Trans World Bank parking garage, which had not been strengthened, were badly damaged.

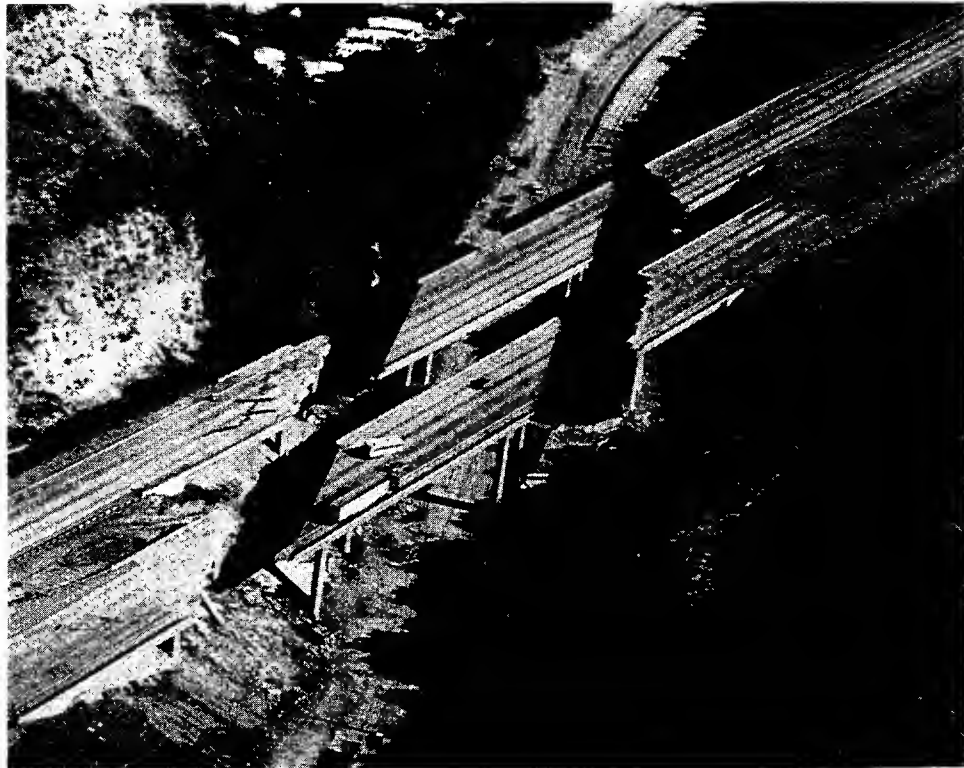
This bridge was designed in 1964 and constructed in 1967. It carries Interstate 5 over Gavin Canyon, about 3 km north of the intersection of Interstate 5 and State Route 14. An aerial photograph of the damaged bridge, after demolition had begun, is shown in Figure 24, and a ground level view is shown in Figure 25. The structure consists of two parallel bridges, with about a 66 degree skew alignment. Each bridge is composed of five spans. Each bridge has four two-pier bents, and there is a structural hinge near each of the two center bents. The superstructure consists of reinforced concrete box girders, and the central portion (between hinges) is post-tensioned. The bridge survived the 1971 San Fernando earthquake with virtually no damage. In 1974, the hinges were retrofitted with cable restrainers. The seat length at the hinges is 200 mm, which by current design standards would be considered inadequate, especially for a structure of this size and flexibility.

Figure 24 Aerial view of the bridge at Gavin Canyon, looking to the east, showing appearance of the four end spans shortly after demolition had begun

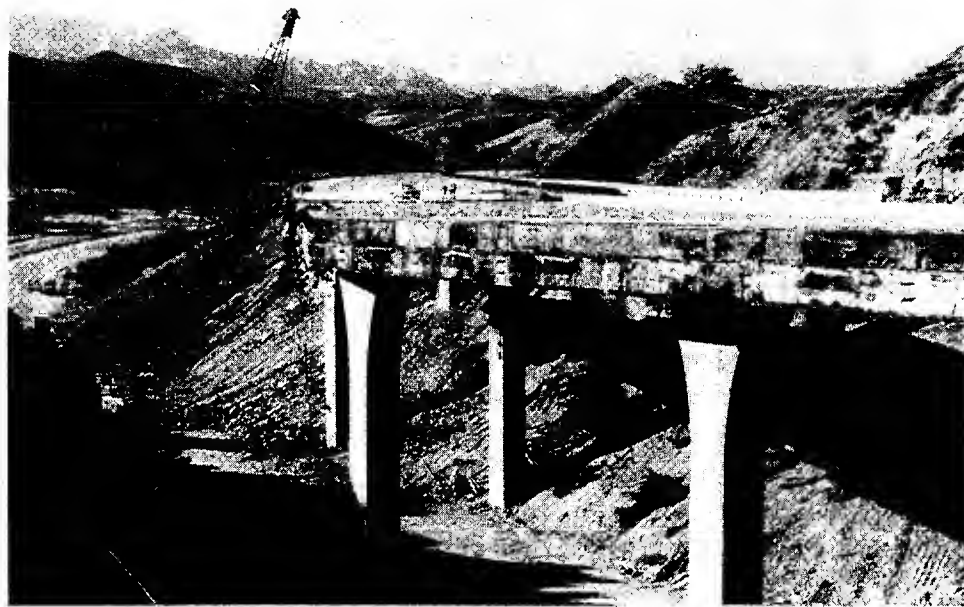
Despite the presence of cable restrainers at the hinges, failure of three of the four end spans of the bridge was apparently initiated by the spans falling off the hinge seats. The fourth end span, at the far western corner of the bridge, partially came off its hinge seat but did not collapse. After support was lost at the hinges, a triangular portion of three of the end spans collapsed. It is likely that the skewed alignment of the bridge was an important contributing factor in this failure. The skewed alignment

Figure 25 Ground level view of the southbound bridge at Gavin Canyon, looking to the northwest, showing the hinge bearing seat near Bent 3.

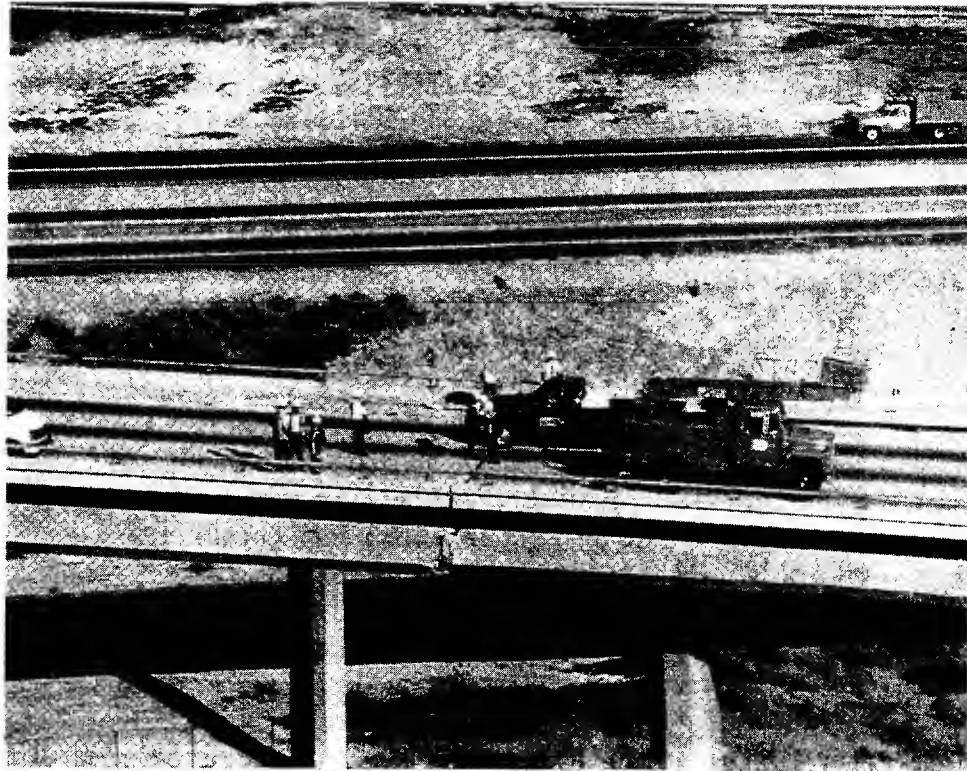
Figure 26 Example of pounding and offset at a hinge in the SR14/I5 interchange

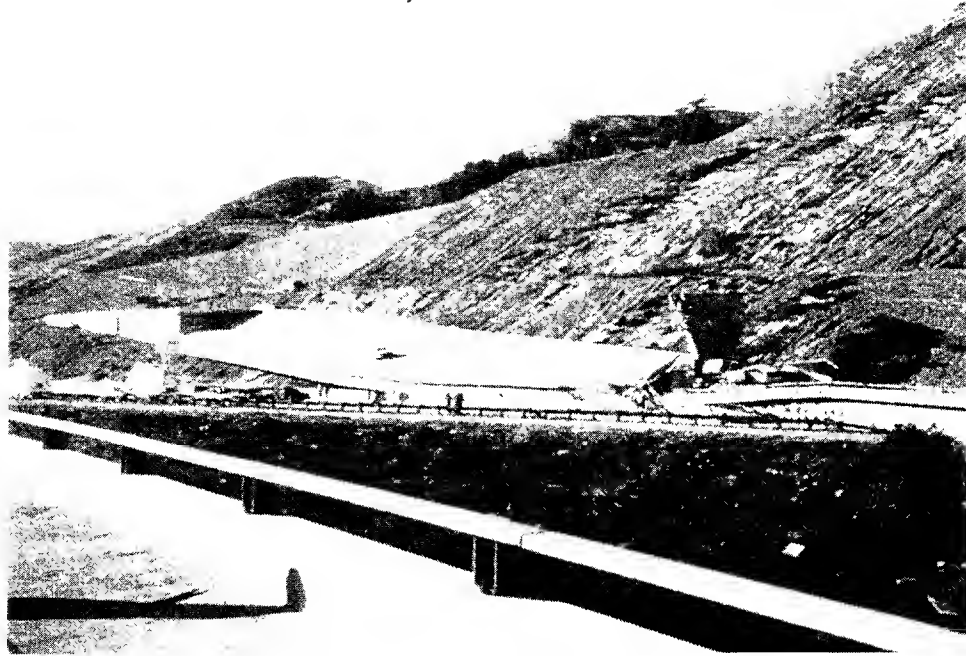
This ramp was designed in 1968 and constructed in 1971. The structure consists of multiple-cell concrete box girders, most of which are post-tensioned, supported on single pier bents with flared tops. The portion of the ramp which collapsed was between Abutment 1 and the hinge located near Pier 4. A ground-level view of the collapsed span is shown in Figure 28, and a view of damaged Pier 3 is shown in Figure 29. The mode of failure of this ramp has not yet conclusively been determined, but the following scenario appears likely. Because Pier 2 was the shortest and stiffest pier in the structure, it probably attracted a large share of the horizontal seismic forces. The reinforcing details of the pier indicate that the pier contained quantities of lateral reinforcement which would be considered inadequate by current standards. Thus it is likely that Pier 2 was damaged and collapsed, pulling the superstructure off the seat at Abutment 1. It was reported that Pier 2 had completely disintegrated in the collapse. This observation is consistent with the conjecture that the pier was initially severely damaged in shear, and was then so badly weakened that it was crushed in compression. Following the collapse of Pier 2, a failure of the superstructure was initiated by excessive shear and negative bending moment at Pier 3. The superstructure sheared off on either side of Pier 3, leaving the pier standing nearly intact, as shown in Figure 29. The span between Piers 3 and 4 then collapsed, pulling the superstructure off the hinge seat near Pier 4.

Figure 28 Overview of the collapse of the SR14/I5 Separation and Overhead, Ramp C, looking to the south at Abutment 1. Pier 3 can be seen at the right of the photograph (Courtesy of EERC)

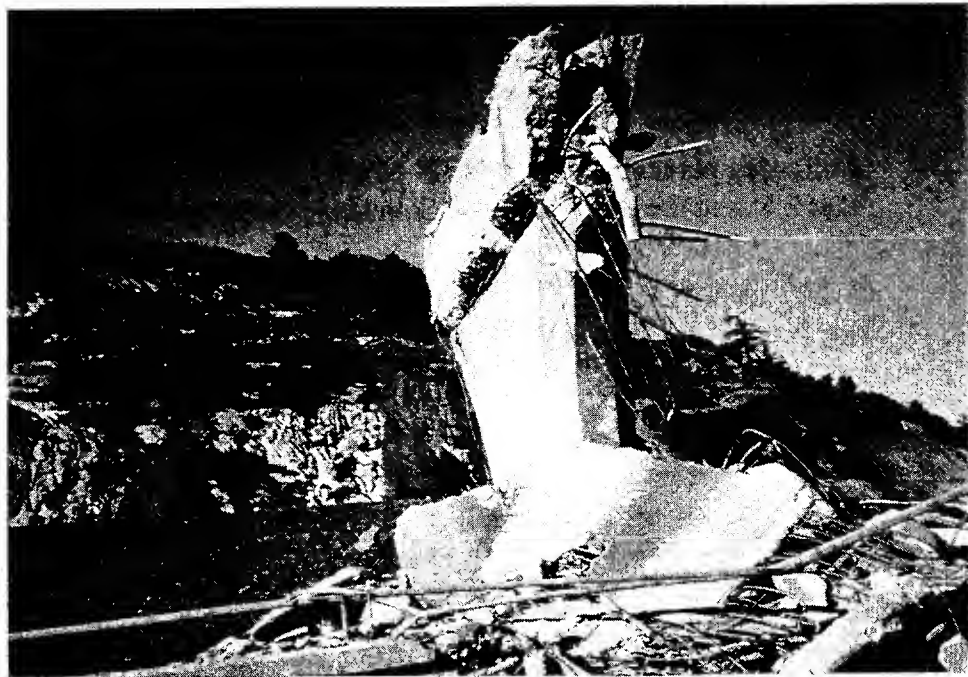
Figure 29 Damage at Pier 3 of the SR14/I5 Separation and Overhead, Ramp C, looking to the west (Courtesy of EERC)

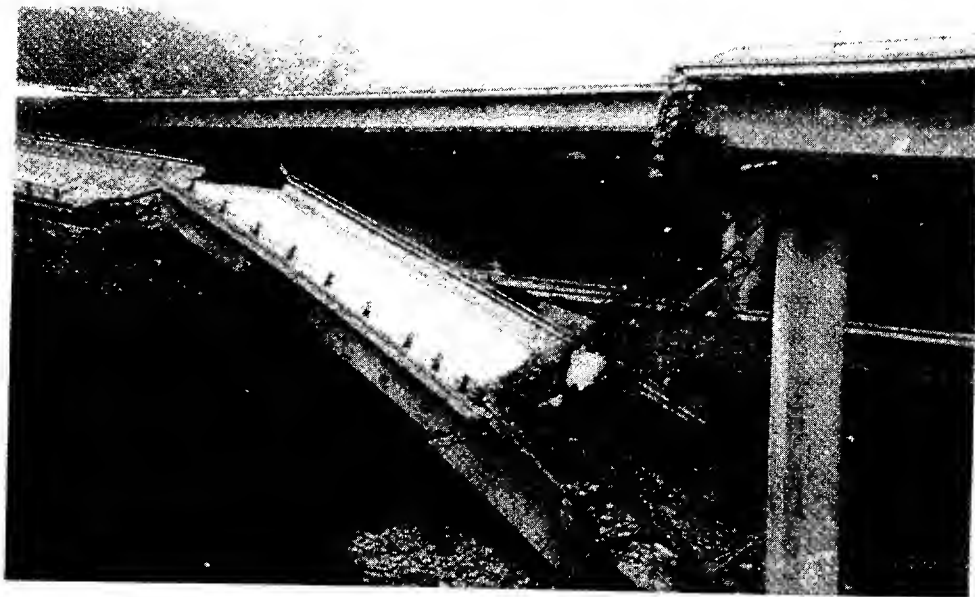
Figure 30 Collapsed portion of the SR14/I5 North Connector Overcrossing, looking east.. Pier 2 was at the left, near the broken hinge on the ground (Courtesy of EERC)

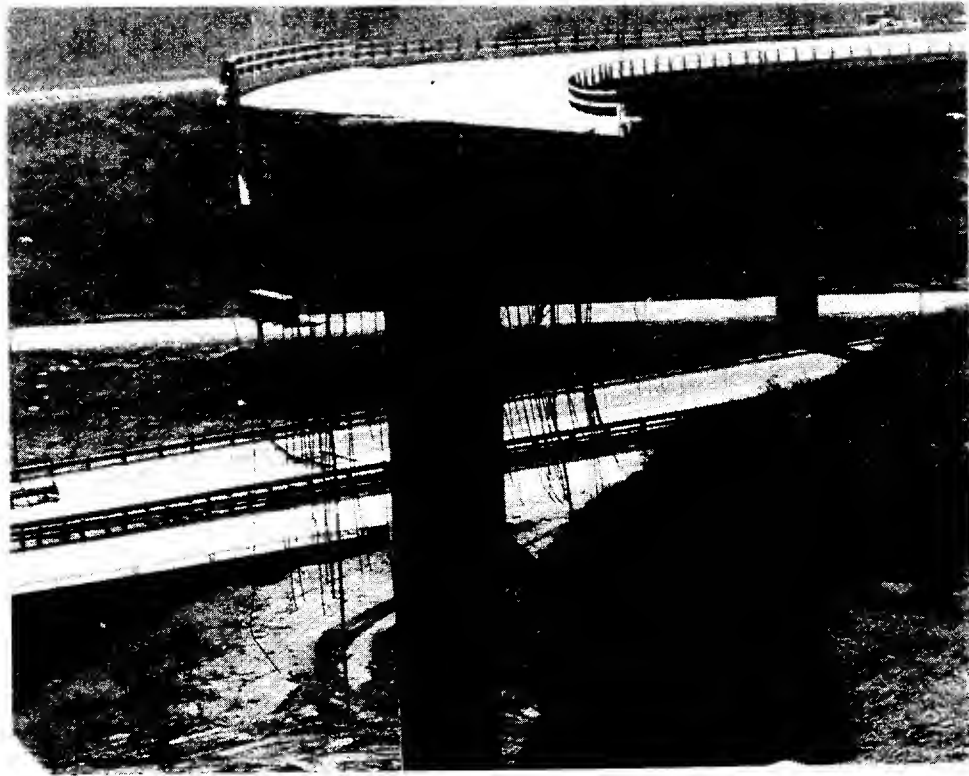
The collapse in the Northridge earthquake appears to have been initiated by the failure of Pier 2. After Pier 2 failed, the simply supported span between Abutment 1 and the hinge near Pier 2 collapsed, and, as shown in Figure 31, the superstructure failed in bending near Pier 3 due to a large negative moment. Pier 2 completely disintegrated, as shown in Figure 32. This is the shortest pier in the structure, so it is likely that it attracted a high level of lateral force, was damaged in shear, and finally collapsed in compression. Pier 10 is similar in height to Pier 1, but the quantities of lateral reinforcement in Pier 10 are greater than those in Pier 1. This is because Pier 2 had already been completed, but Pier 10 had not yet been constructed, when the 1971 earthquake occurred. Following the 1971 earthquake the plans for Pier 10 were revised to provide increased lateral reinforcement.

Figure 31 View of the flexural failure at Pier 3 of the SR14/15 North Connector Overcrossing, looking to the south

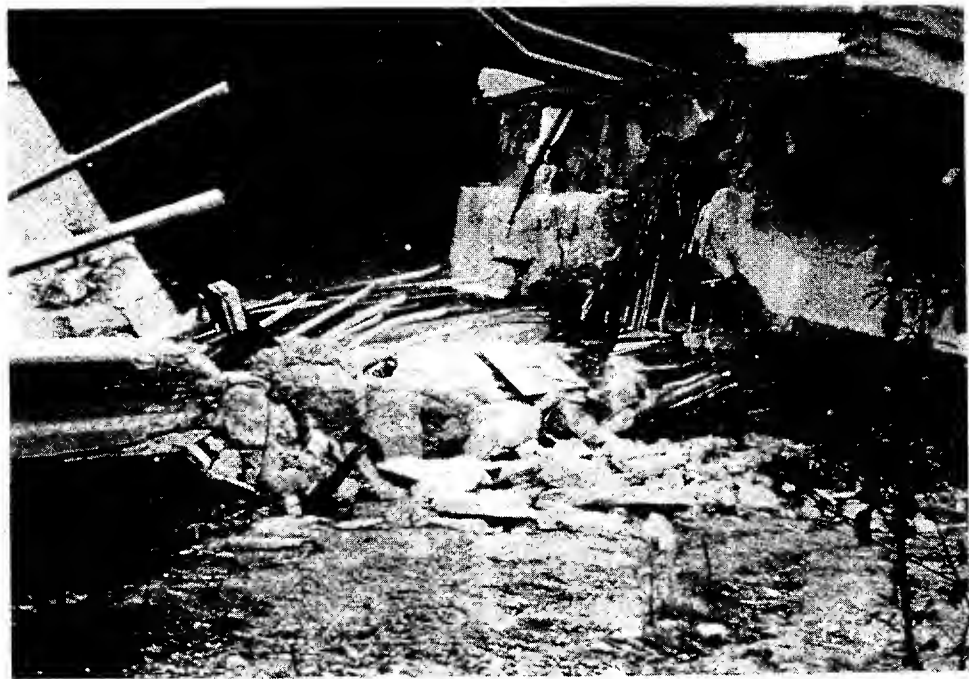
Figure 32 View of crushed Pier 2 and the hinge near Pier 2 (Courtesy EERC)

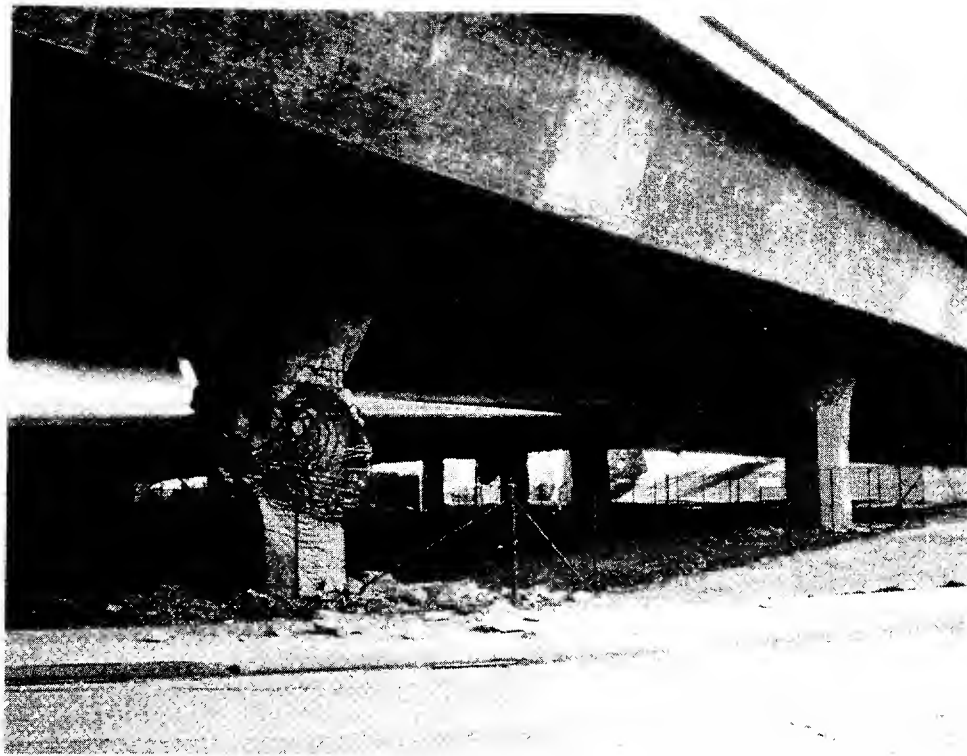
Figure 33 Damage to piers of the SR118 Mission-Gothic Undercrossing, looking to the northwest at the north face of the westbound bridge, Bents 3 (foreground) and 2.

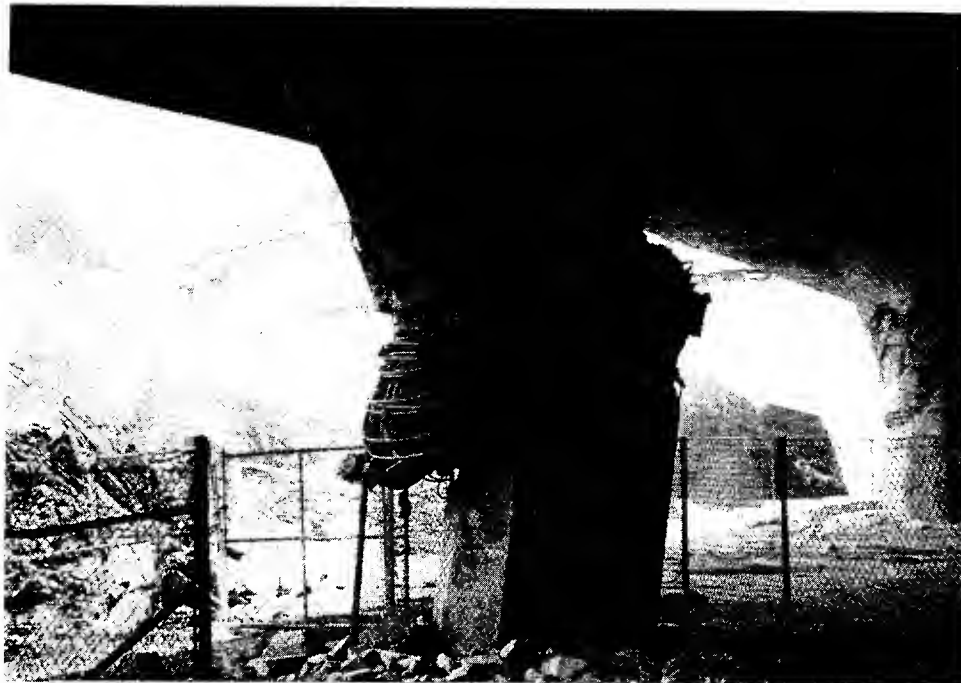
Figure 34 Damage to a pier of the SR118 Mission-Gothic Undercrossing, looking to the northwest at the southernmost pier of Bent 3 of the westbound bridge.
